**INVESTIGATION**

**COLLAPSE**

**HOTEL VENDOME**

**CITY OF BOSTON**

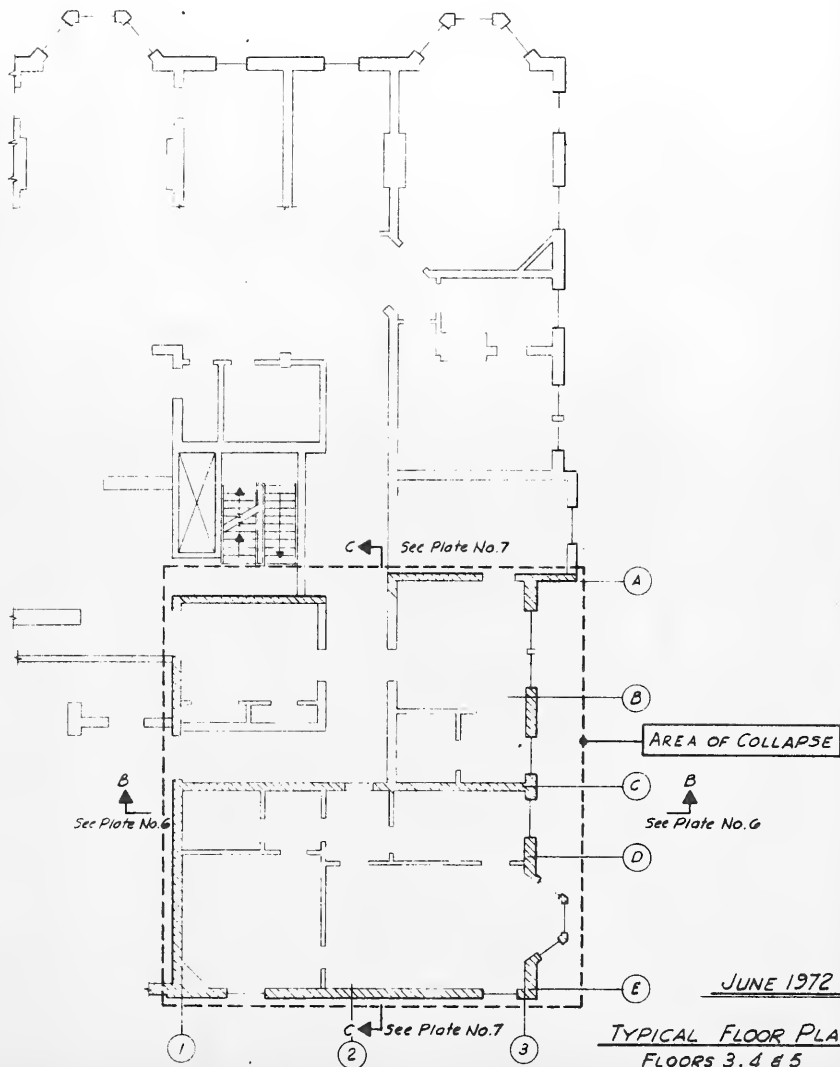
PLATE No. 4

At this point the exterior ends of the floor sections pushed out the lower portion of the E-Line Wall resulting in the vertical collapse of the upper portion of the same wall. The partial collapse of the Line 3 Wall at Dartmouth Street quickly followed the collapse of the E-Line Wall.
